The boat building

Testing the hypothesis

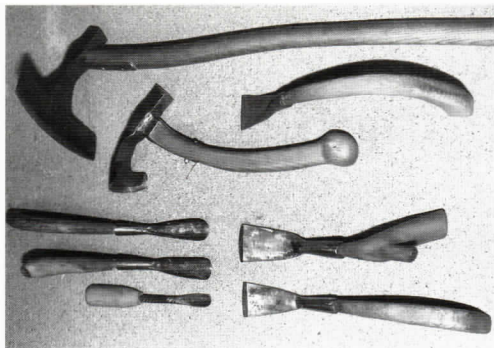
Fig. 2. Tools used for reconstructing the Hjortspring replica. Photo: K.V. Valbjørn.

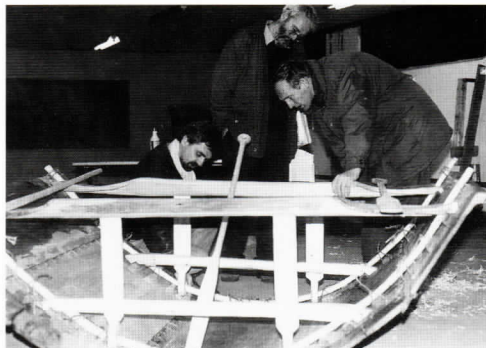
Fig. 3. Sample of middle section. Photo: K.V. Valbjørn.

middle section of the boat on the scale 1:1, containing two frame-systems (fig. 3), and finally the first 5 metres of the prow, containing one frame. For these samples they used local lime-trees (*Tilia grandifolia*). The training period for the boat-building group was two years and, 1,650 man-hours were logged.

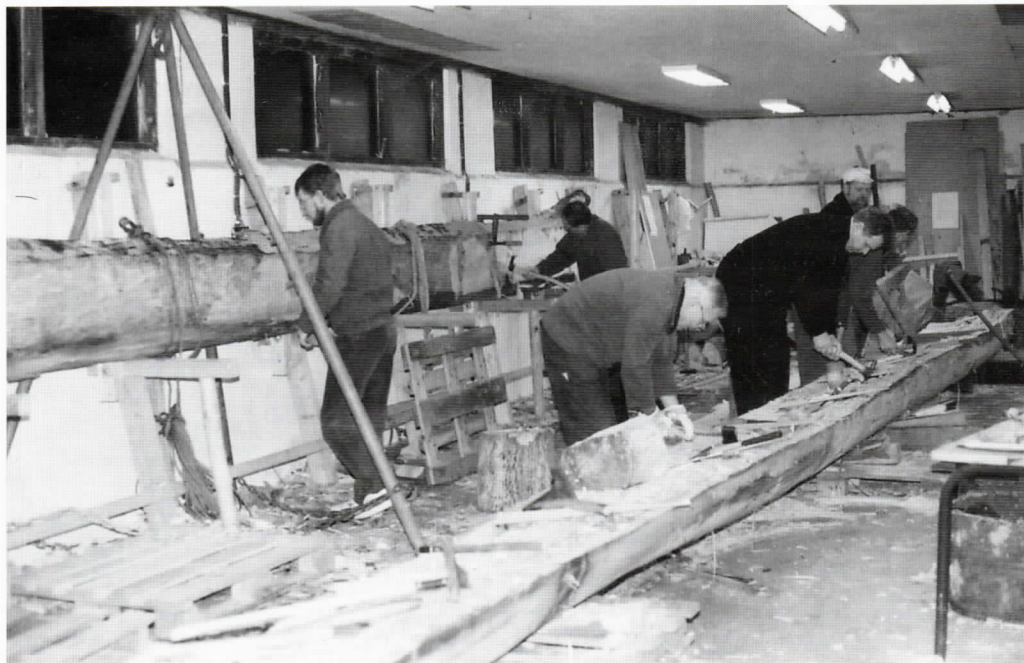
Fig. 5. Plank production. Photo: K.V. Valbjørn.

Each of the planks (the bottom plank, the two side planks and the two gunwale planks) required half a trunk because of their width. Fig. 5 shows a side plank in position in a split trunk. A loose core in two of the trunks caused much trouble and eventually we had to glue an addition to two of the planks to obtain the necessary width. Tests showed, however, that glued planks had the same elasticity and strength as whole planks.

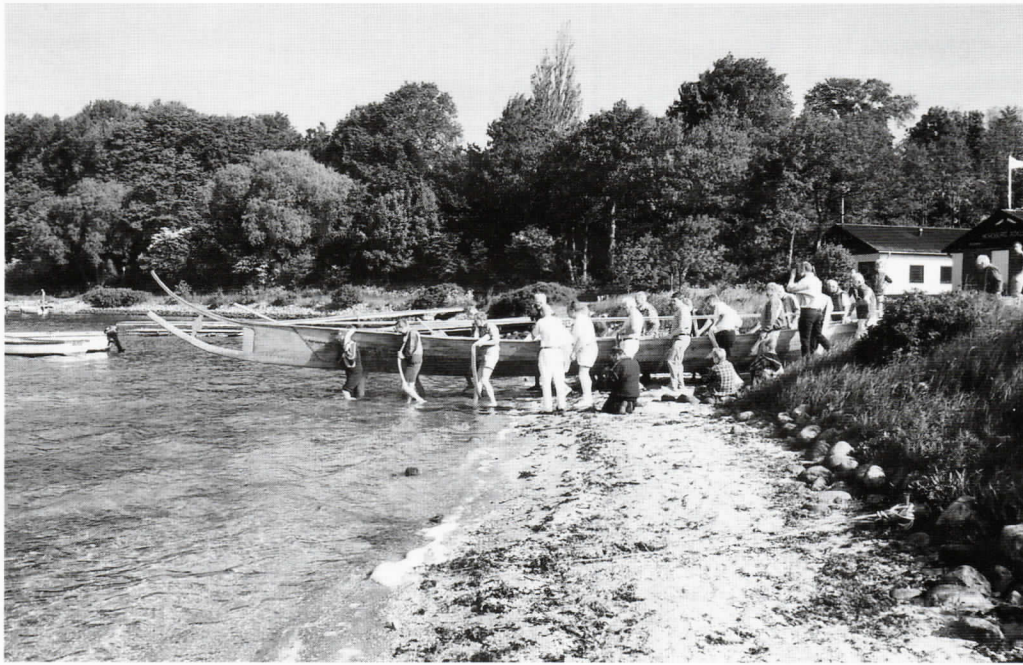
Fig. 7. Launching.
Photo: K.V. Valbjørn.

The boat was launched on 29th May 1999 and named *Tilia Alsie* (fig. 7). During the summer of 1999 the boat sailed on six separate occasions. Between sailings it was wheeled up to the building, where it was built.

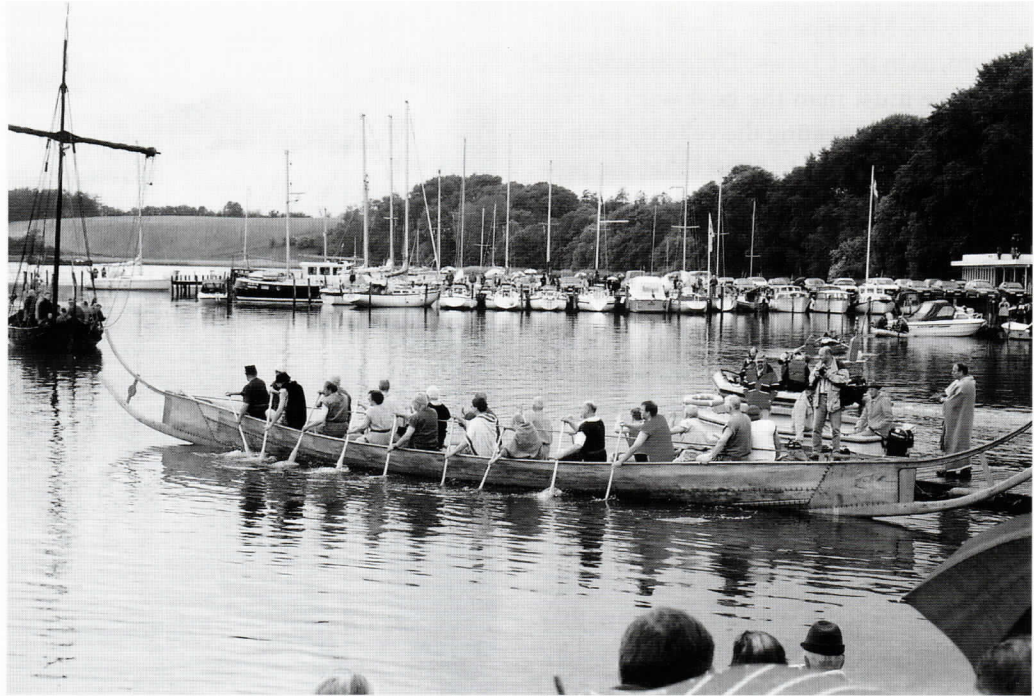
Fig. 8. Sailing. Photo:
K.V. Valbjørn.

Manning the boat produced an immediate feeling of instability. Sitting in the boat, before sailing commenced, gave the same impression (fig. 8). Once paddling began, it was felt that the boat functioned well with respect to stability. No doubt the crew counteracted any heeling by moving of their bodies. The velocity probably helped as well. The boat felt safe.

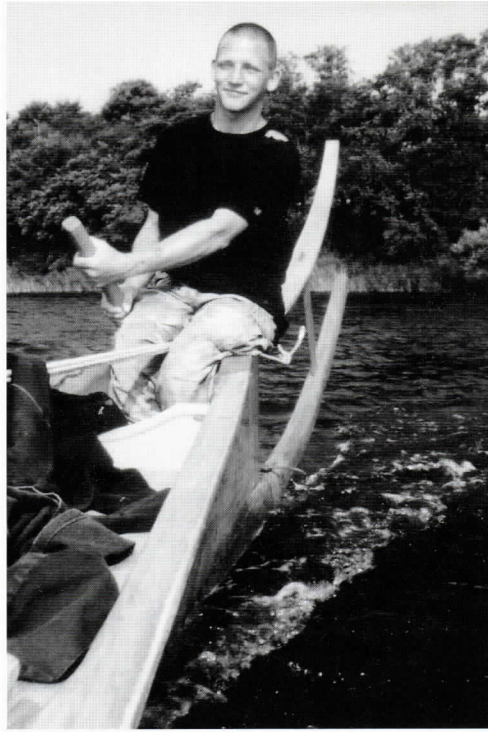
Fig. 9. New position of steering oar. Photo: K.V. Valbjørn.

horizontal position for the oar and this did not have a convincing effect. Depending on the direction of the wind the steering was inadequate. A test with both steering oars, one at port and the other at starboard, did not help much. Eventually the steering oar was lashed to the keel horn at its root and operated by twisting it in an almost vertical position, just like the steering oars of the Nydam- and Viking-ships (fig. 9). In this position the steering was convincingly good. A test with the other oar mounted similarly but at the prow and letting that do the steering alone also gave good results. Using both steering oars, one at each end of the boat, gave excellent results.

We shall have to investigate the position of the steering oar more closely. The one that we adopted has not been proved to be the right one, although it did give better results than the position first chosen.
